# DebrisSat Laboratory Analyses

January 5, 2015

Aerospace Technical Operating Report No.  
TOR-2015-00876

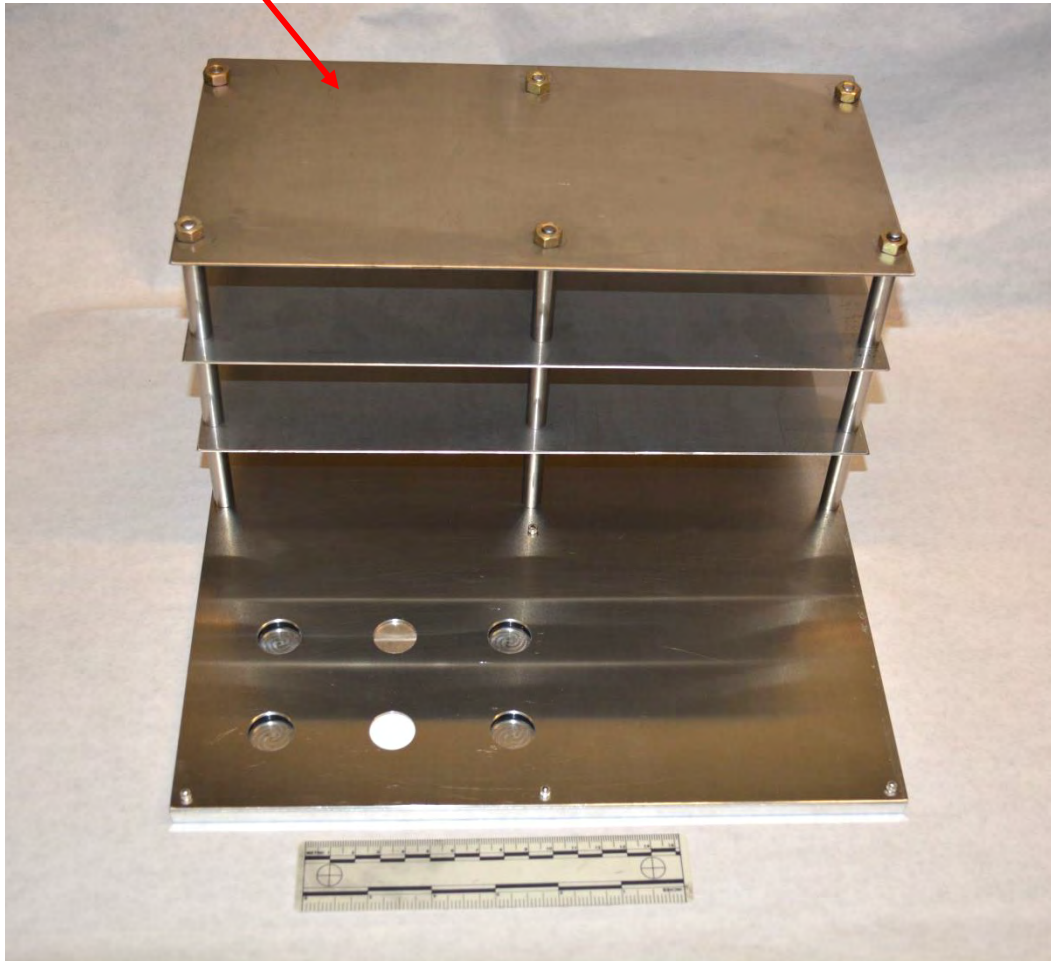
# Witness Plate: Pre Test

Witness plates located in same position in chamber as Debris-LV.  
~3 meters up range of DebrisSat.

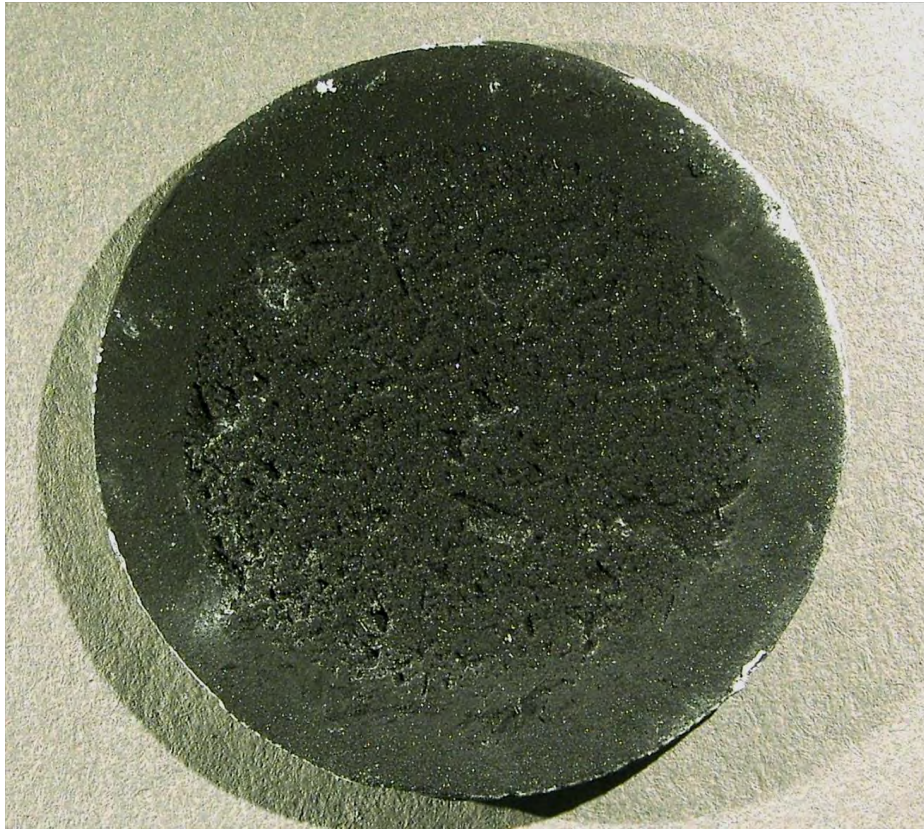
# Witness Plate Post Test: Z93 Painted Aluminum Disks

Exposed

Protected

Z-93 paint consists of ZnO in a potassium silicate binder

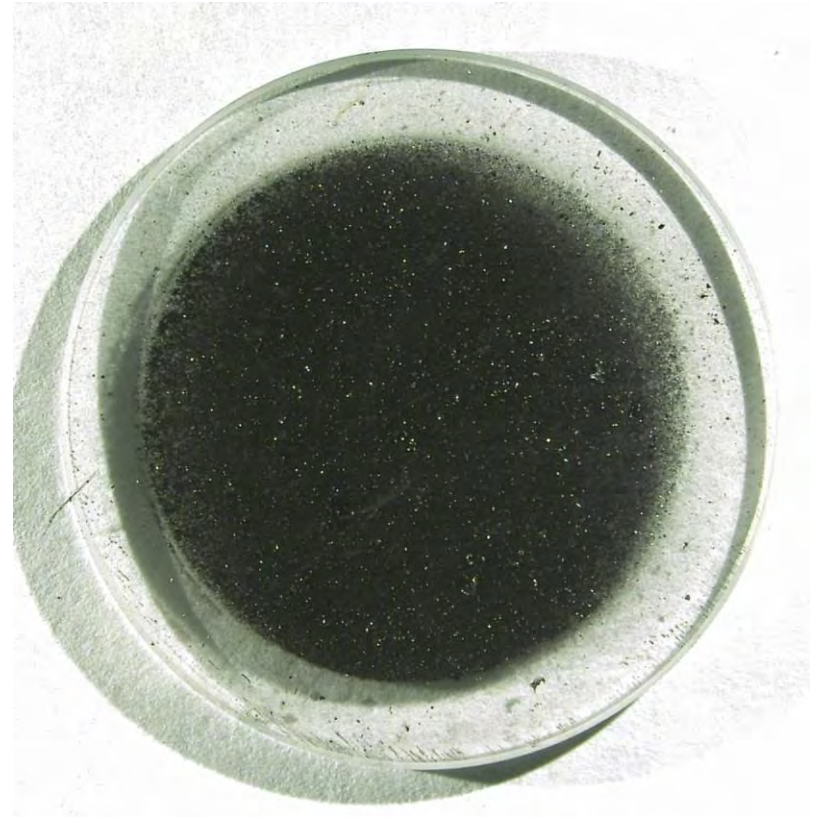
# Witness Plate Post Test : Fused Silica Disks

Protected (C1)

Protected (D1)

The directly exposed disks were destroyed
